Manhole Inspection Summary

Manhole # S31WW1015MH

Location Address: **105 TURNBRIDGE RD**

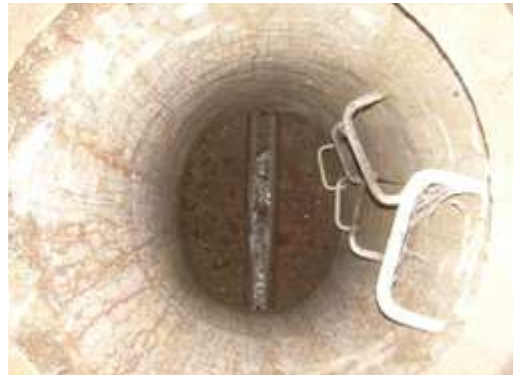
Top View

Bench ☒ Exists Material: **Brick** ☐ Parged ☒ **Debris** (not Condition related)

Bench debris.

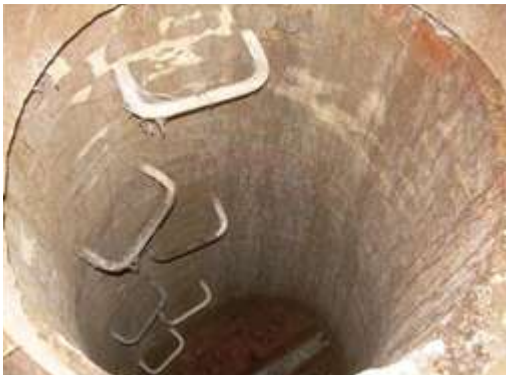
Defect

Condition: ☐ Sound ☐ Cracked ☐ Root Intrusion ☐ Loose Brick ☒ **Deteriorated**

Infiltration: ☐ None ☒ **Joint** ☐ Cracks ☒ **Mortar** ☐ Roots ☐ Wall

Adjustment deterioration and infiltration - other side.

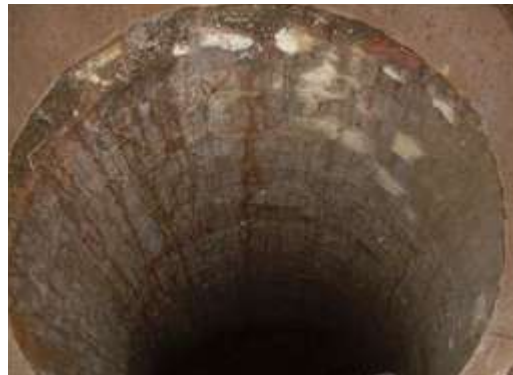
Defect

Adjustment deterioration and infiltration.

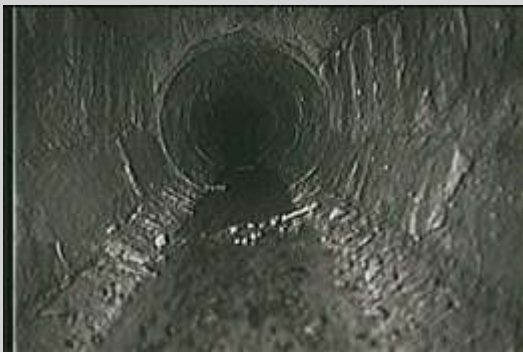
8 in. Circular Gravity Sewer Pipe Out @ 12 O'Clock

Infiltration: **Evidence** Pipe Seal Cond: **Cracked**
